# Manhole Inspection Summary

Manhole # S25QQ1022MH

**Location** Address: **6 CLUB RD**

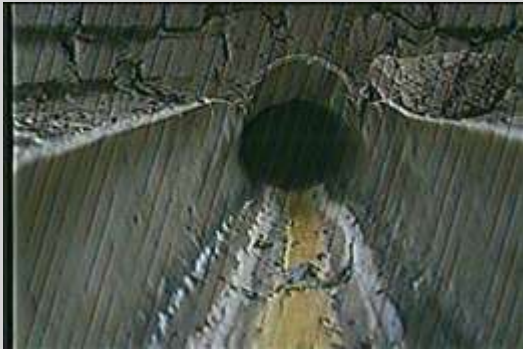
### 6 in. Circular Gravity Sewer Pipe Out @ 12 O'Clock

Pipe Material: **Unknown** ☒ Pipe Lined

Infiltration: **None** Pipe Seal Cond: **Unknown**
